Clara Barton National Historic Site

Historic Structure Report

Part: 1
Physical History /Condition Assessment

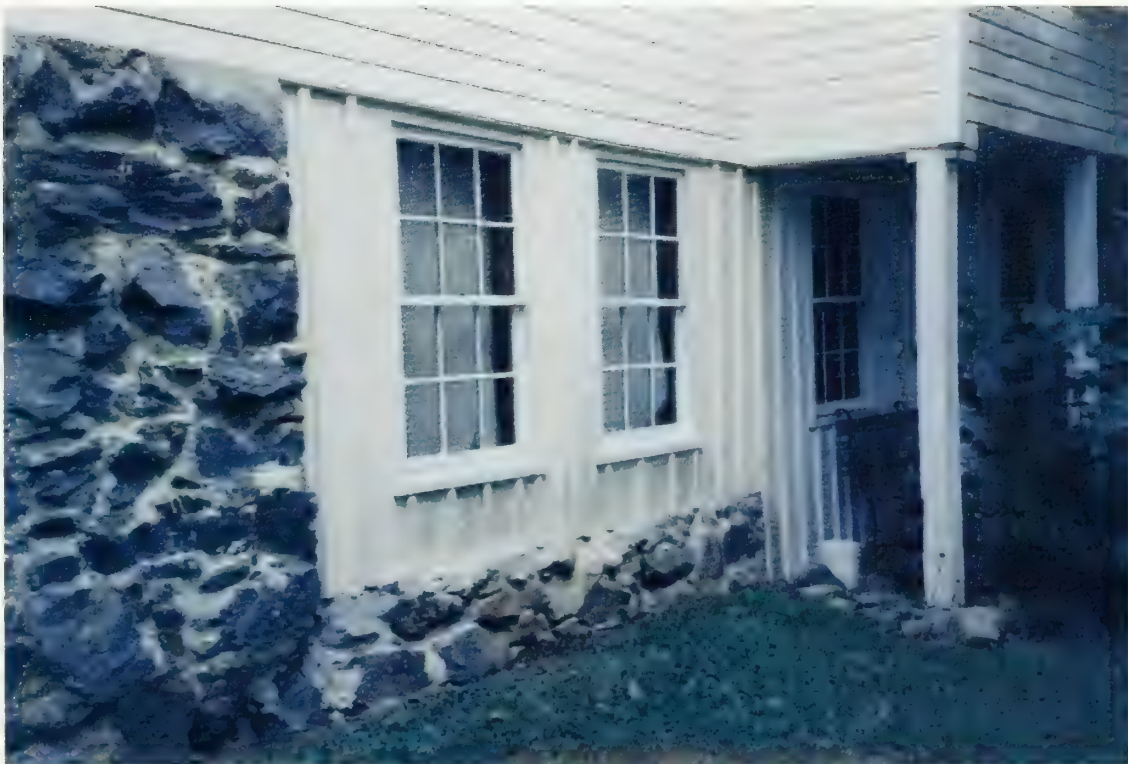
The grade at the site sloped downhill from the front of the house to the rear. At the back of the house, the grade dropped off sharply down to the C & O Canal and the Potomac River. The retaining wall, built utilizing the spoil from the demolition of the front facade, was used to contain soil excavated from under the house as the cellar was excavated. This created a small area of level grade directly behind the house (see Figure 3).

Figure 3: View looking east at the back elevation of the house showing the area that was backfilled behind the retaining wall to create a relatively level area behind the house.

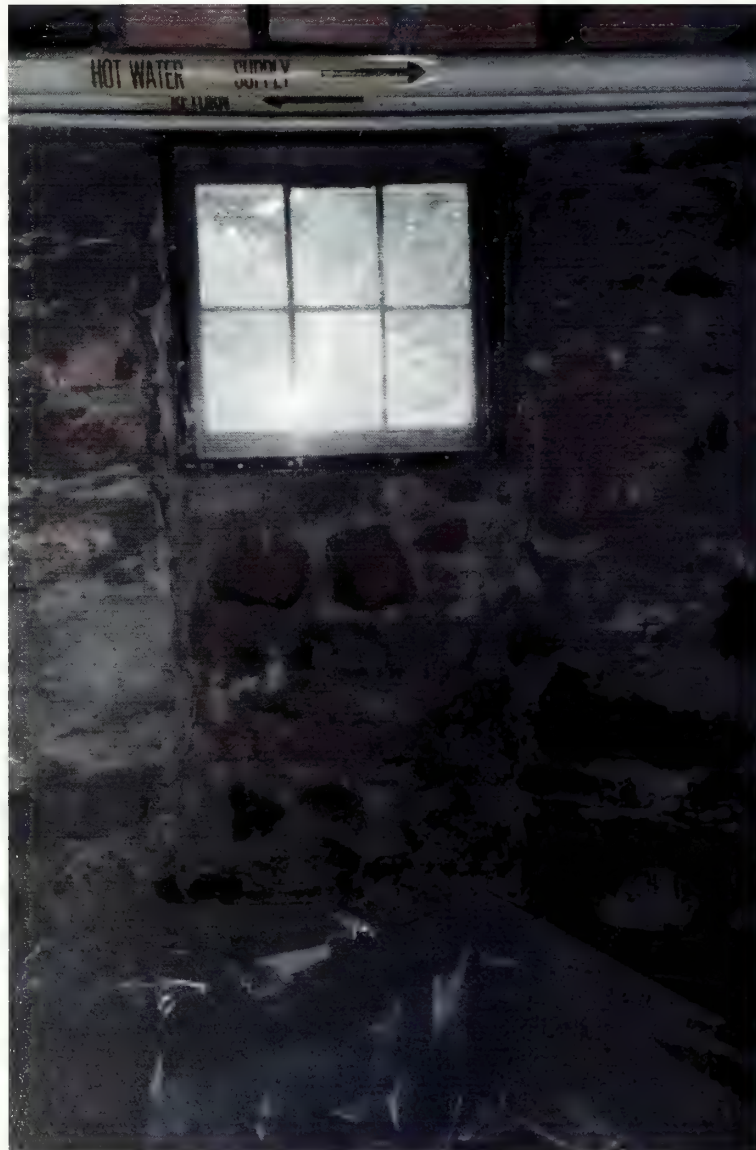
Figure 4: The spaces between the original stone foundation piers were infilled when the basement was created. Here, rubble stone infill was used for the part of the wall that is below grade.

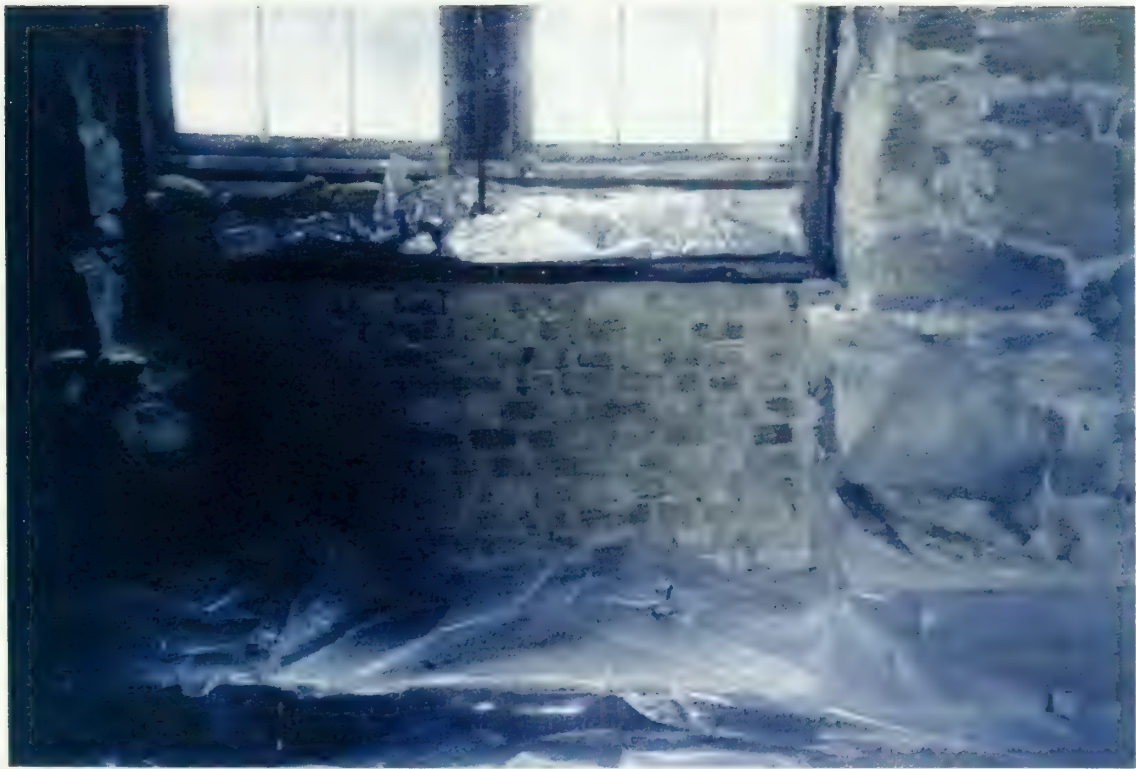
Figure 5: *The spaces between the original stone foundation piers were infilled when the basement was created. Here, brick infill was used for the part of the wall that is below grade.*

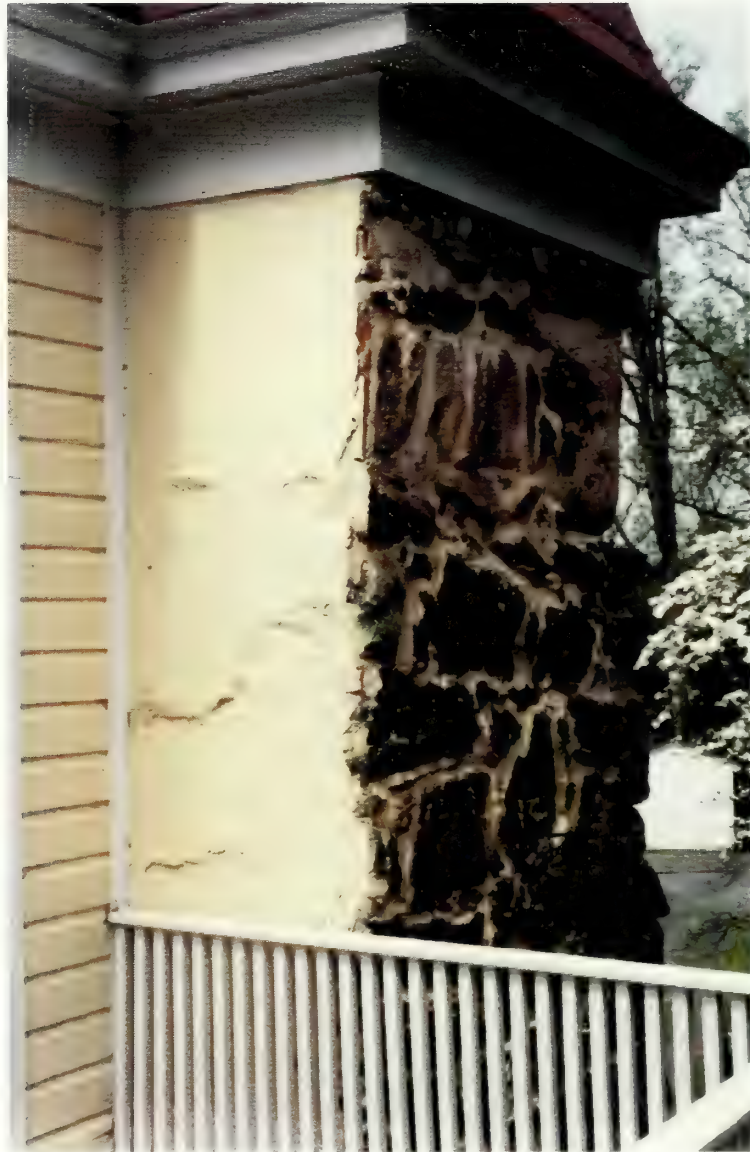
Figure 6: View of the inside face of one of the stone corner piers showing how the rough stone edge was "smoothed over" with cement plaster.

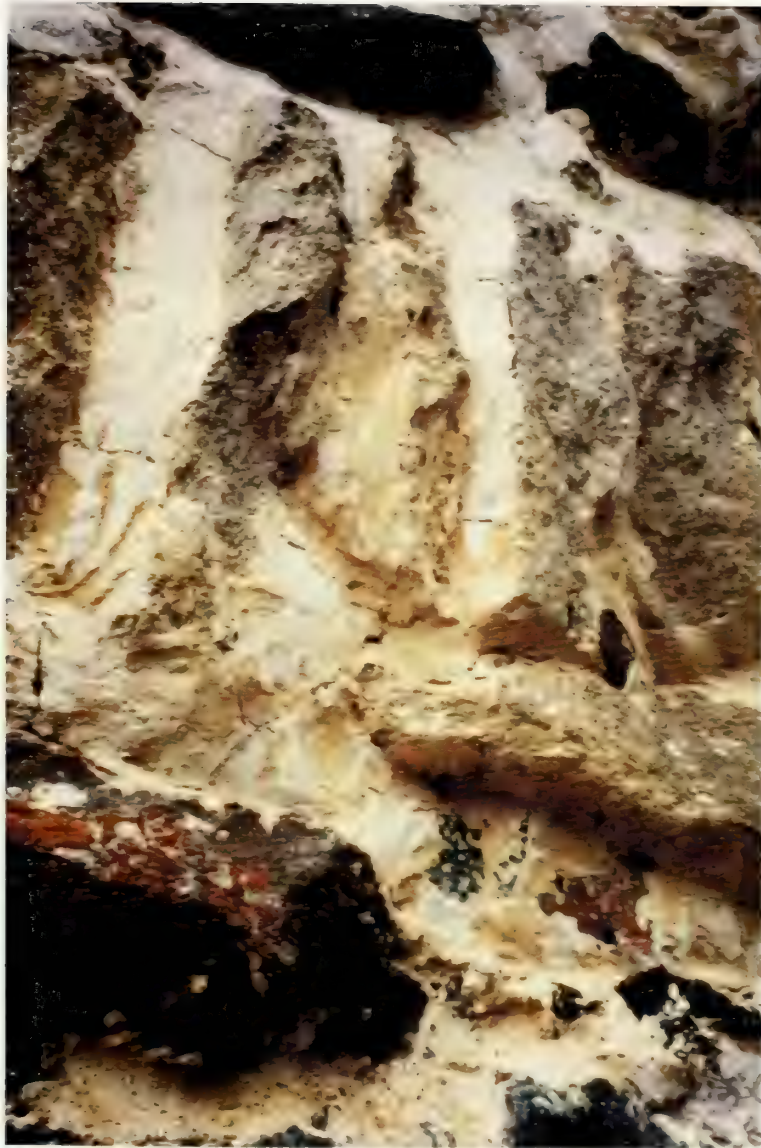
Smoothing over the stone piers is almost certainly a reference to the inside faces of the piers that flank the front facade. Since the piers were part of the original stone facade, a jagged edge was left where the demolition stopped. As can be seen today, this rough edge has been smoothed over with cement parging (see Figure 6). Photographic evidence and remnants of paint on the piers clearly show that the piers were indeed painted to match the house (see Figure 7).

Figure 7: Close-up view of one of the stone corner piers showing remnanis of paint. Since the piers were covered with ivy for most of the 20th century, this is very likely the paint applied after the June 25, 1897 decision to "...have the stone piers...colored like the rest of the house."

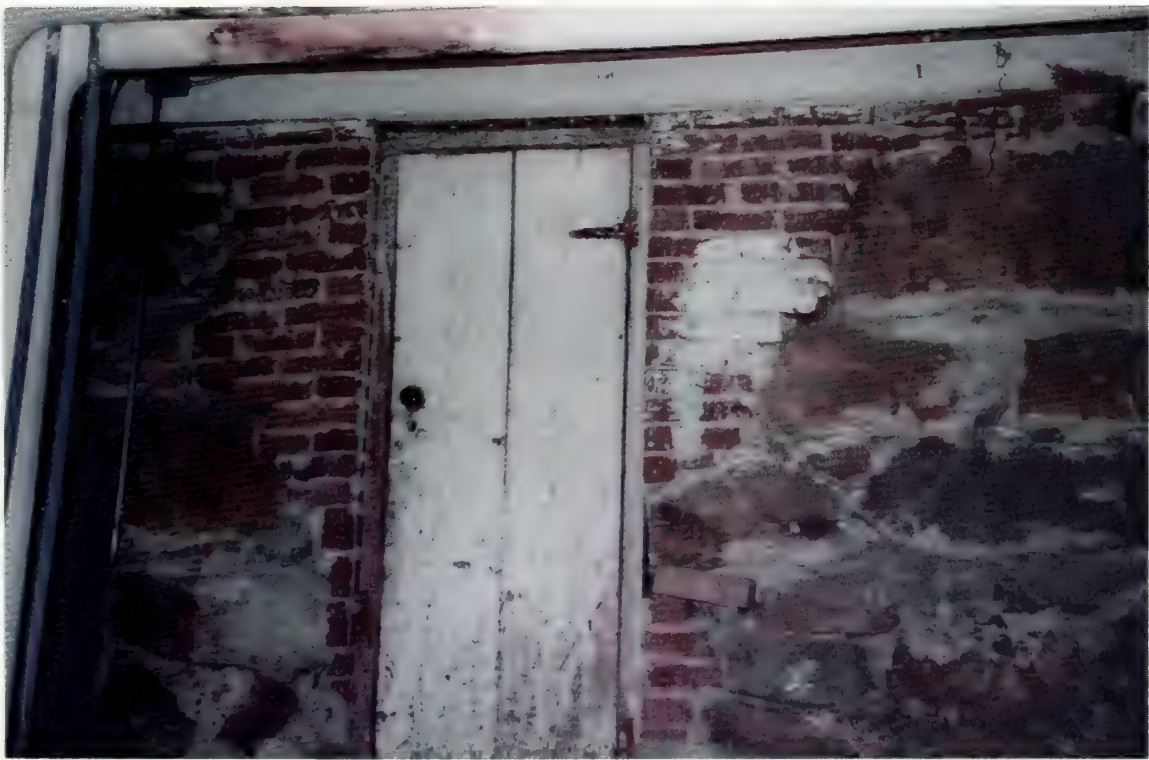
***Figure 11:** View of the doorway into the vault cellar. The stone foundation of the vault probably did not originally have a door. The way that the brick infill angles back towards the top of the opening suggests that the stone was broken out to create the door opening.*

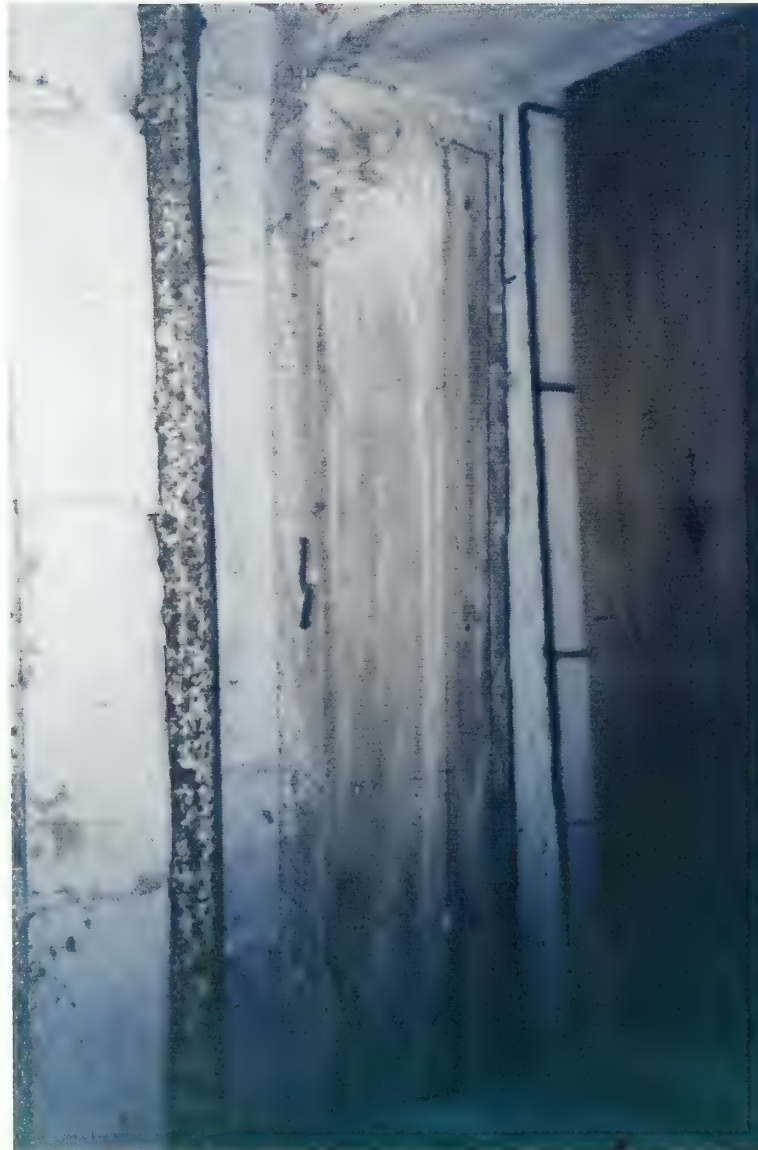
Figure 12 Further evidence that the vault cellar door is not original are the iron pipes that have been used as lintels across the door opening.

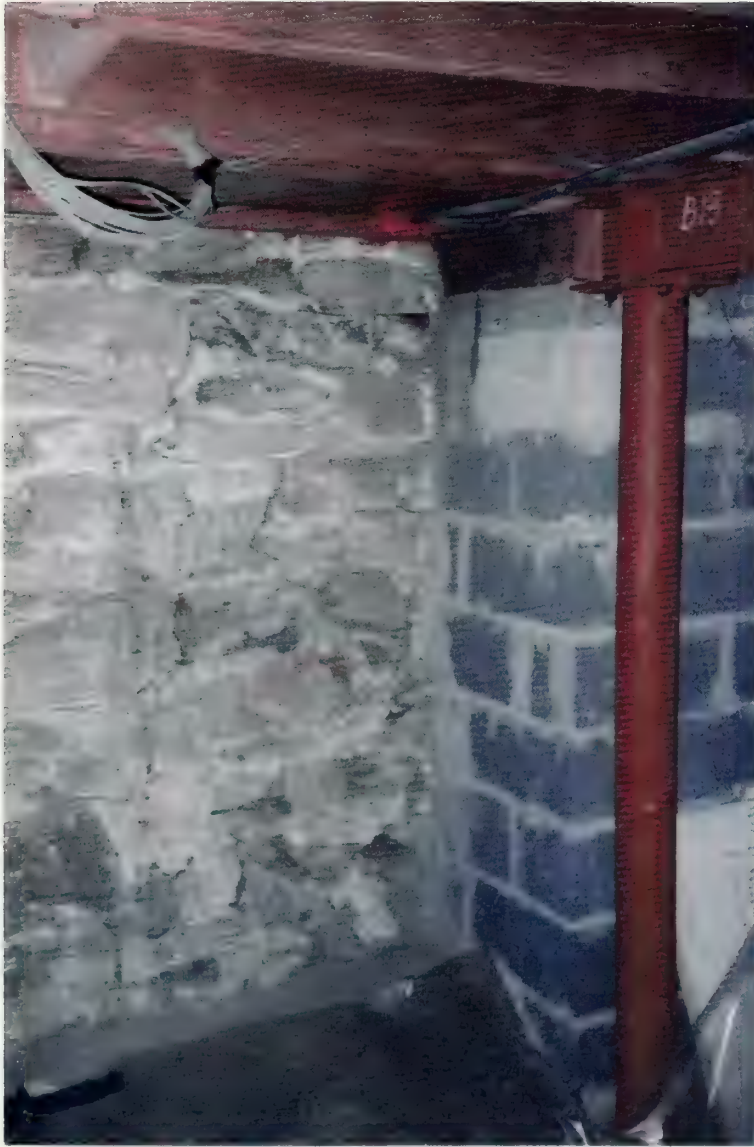
323. The first floor structure is reinforced when the original wood beams are replaced with steel, and the random assortment of wood and concrete block support posts are replaced with steel columns (see Figure 15), existing 2 x 8 floor joists are supplemented with additional joists.

Figure 15: View of the new steel post and beam structure. Notice that on top of the concrete block wall the original wood beam remains in place. These beams appear to be hemlock, one of few places where this wood can be found in this building.

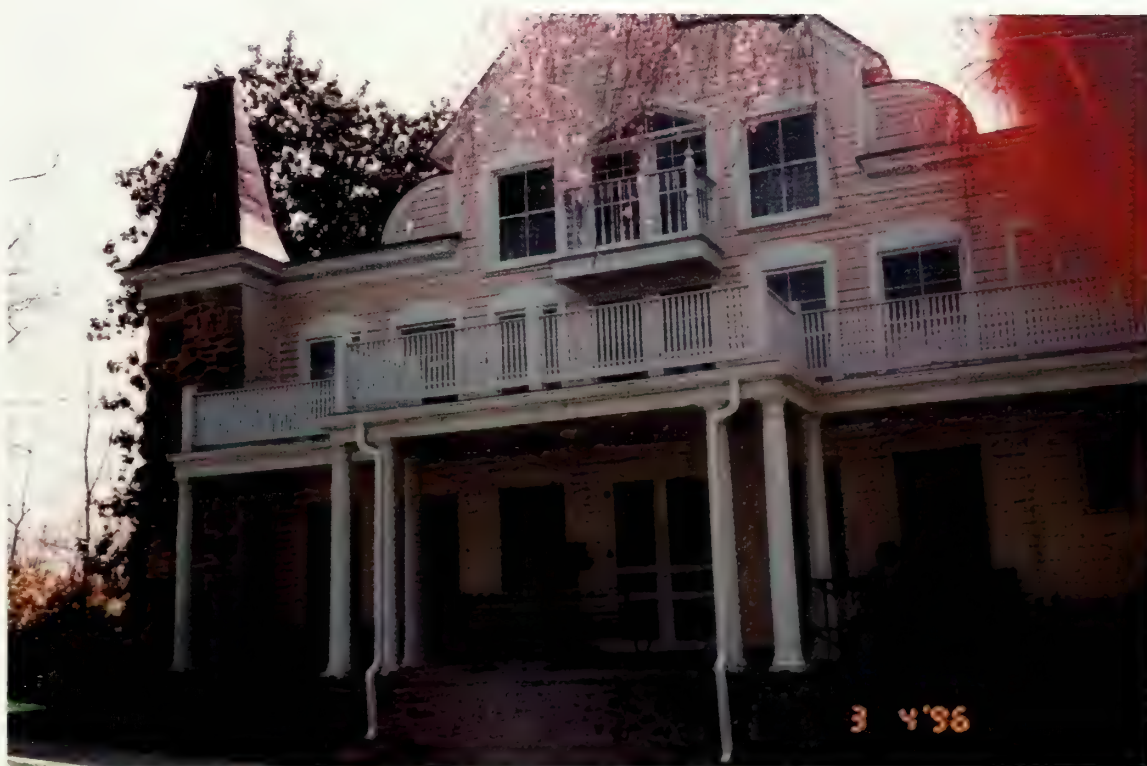
Figure 19: Contemporary view of the front elevation of the Clara Barton House showing the two story porch constructed by Dr. Hubbell in 1919. Virtually all of the wooden members of the original porch have been replaced over time and many of the existing porch parts, including the columns, do not exactly match the original porch components. Notice the two small casement windows that have been installed inside the surrounds of the original, blind vault windows.

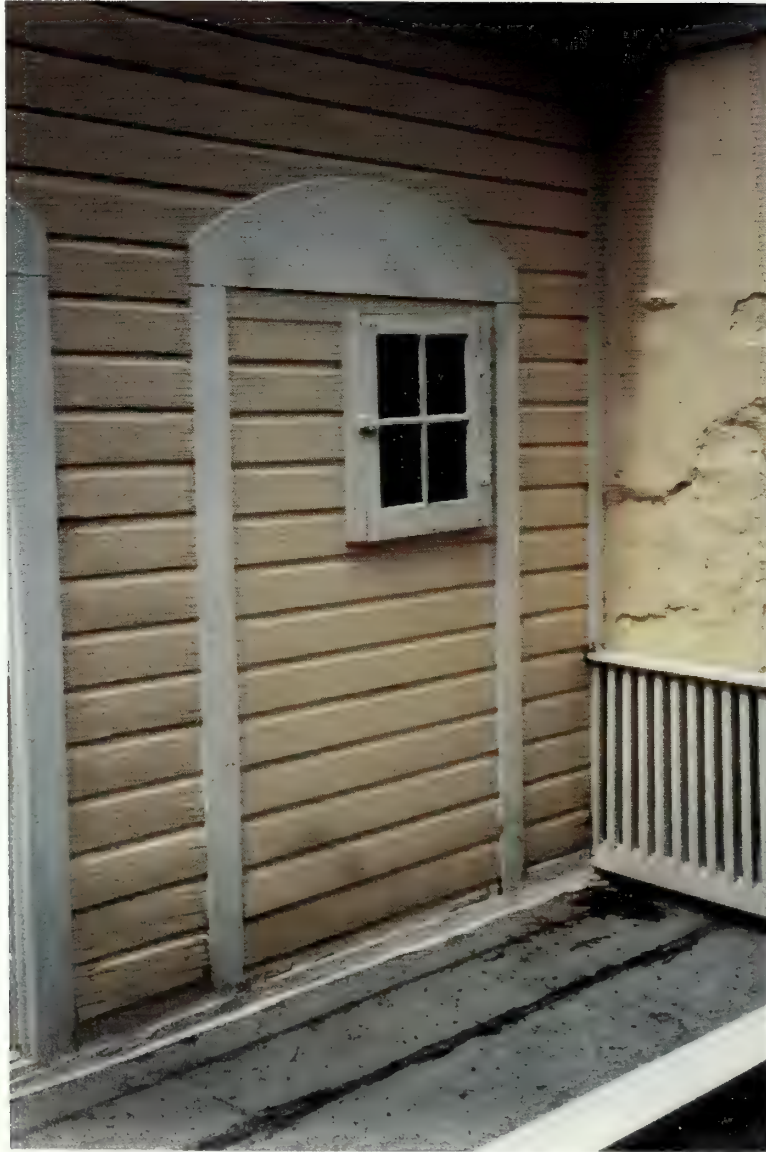
Figure 20: Close-up view of the vault window on the second floor. Notice how the frame of the original full-sized window has been infilled with German siding to match the rest of the house. The small four-light casement window was installed when the building was converted to apartments.

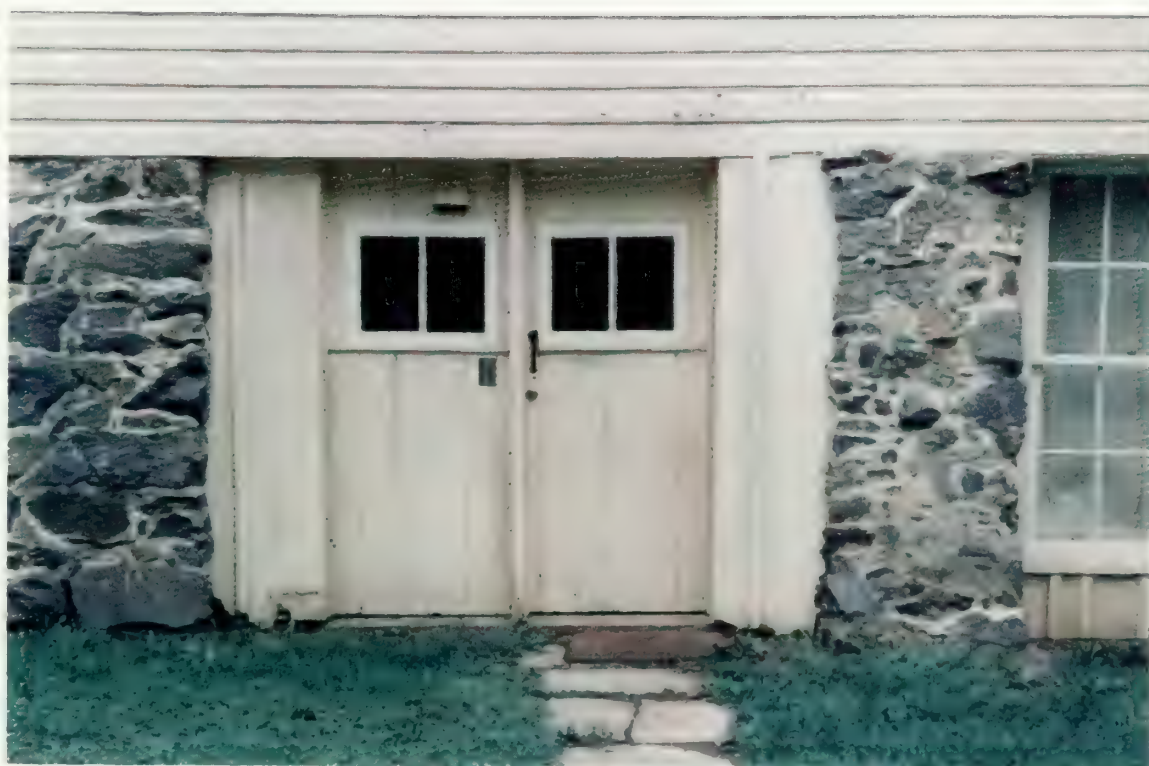
Figure 25: Two-light windows in the vertical board doors that open into what was historically the basement summer kitchen. The stone pier to the right of the doors appears to have originally extended out perpendicularly from the wall. The face of the pier is irregular and remnants of the extension are visible at grade level. It is not known what the purpose of the extension was.

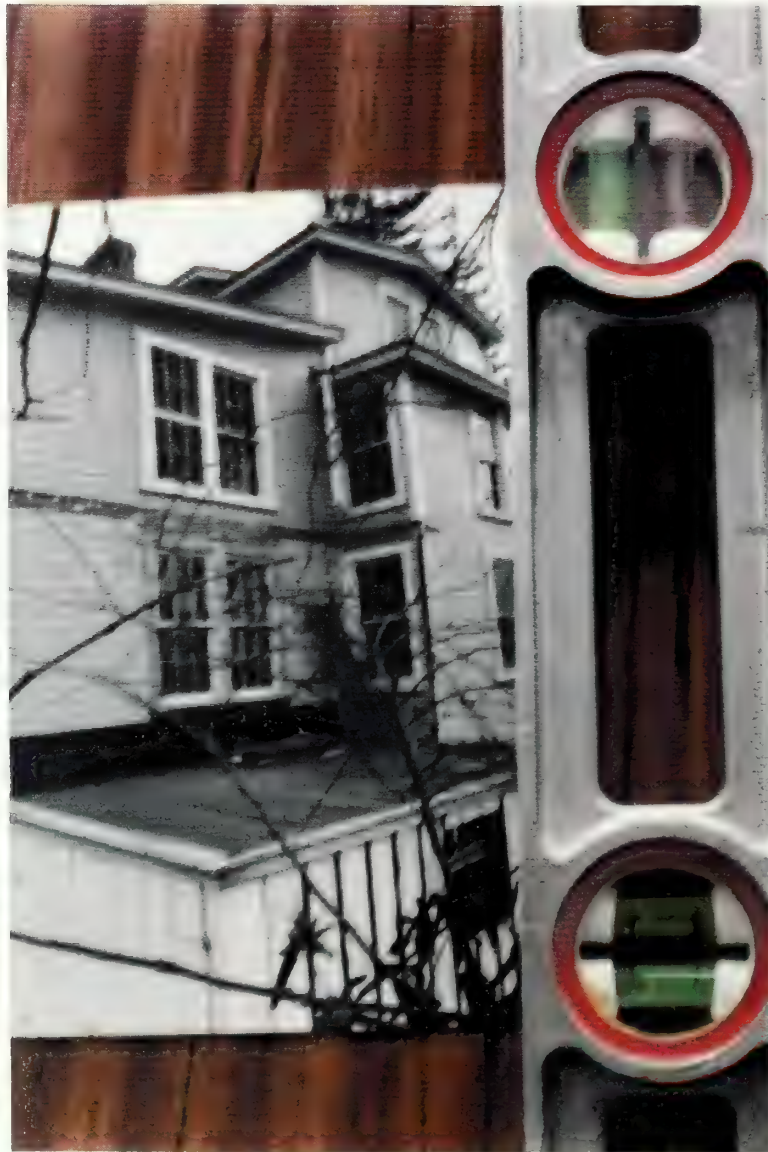
Figure 26: View of the west corner of the Clara Barton House taken after the demolition of the two story rear porch, but before the removal of the garage. The french doors that were installed at the first floor level have already been replaced with double-hung sash. Note the areas of missing siding in the places where the porch was attached to the rear elevation of the building.

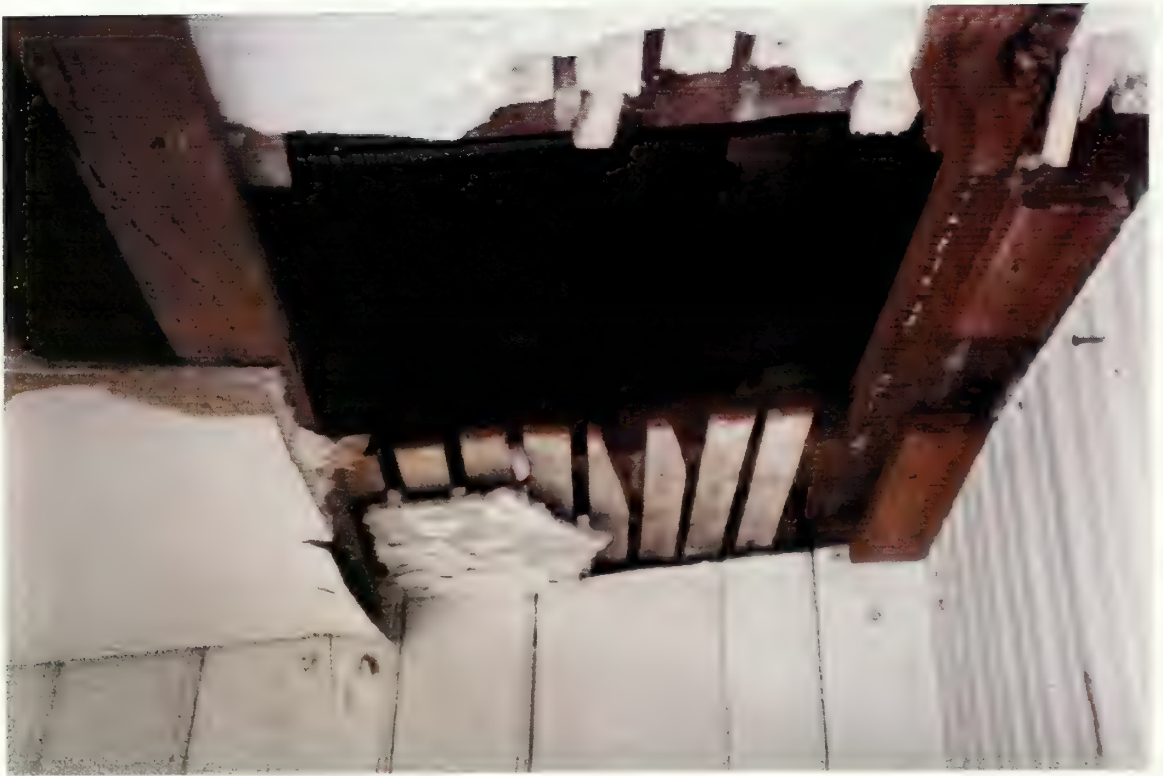
Figure 30: View of the partially demolished plaster and wood lath ceiling in the bathroom (room 209) typical of the plaster used in the house.

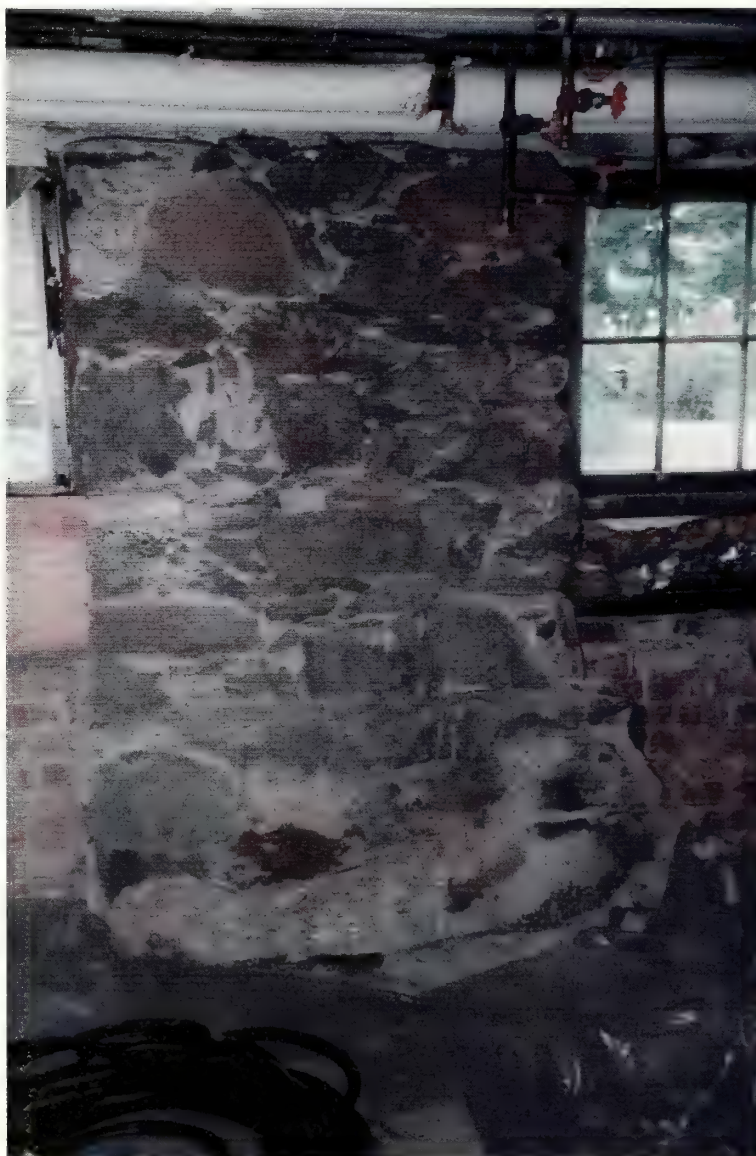
Foundation: Except for the front elevation, where the foundation is a continuous uncoursed rubble stone wall, the foundation consists of irregularly sized and spaced uncoursed rubble stone piers (see Figure 81).

Figure 81: View of the southeast elevation of the Clara Barton House showing how the foundation piers are irregularly spaced and sized. Also notice that basement windows toward the rear of the house are six-over-six double-hung while those farther toward the front have six light fixed sash.

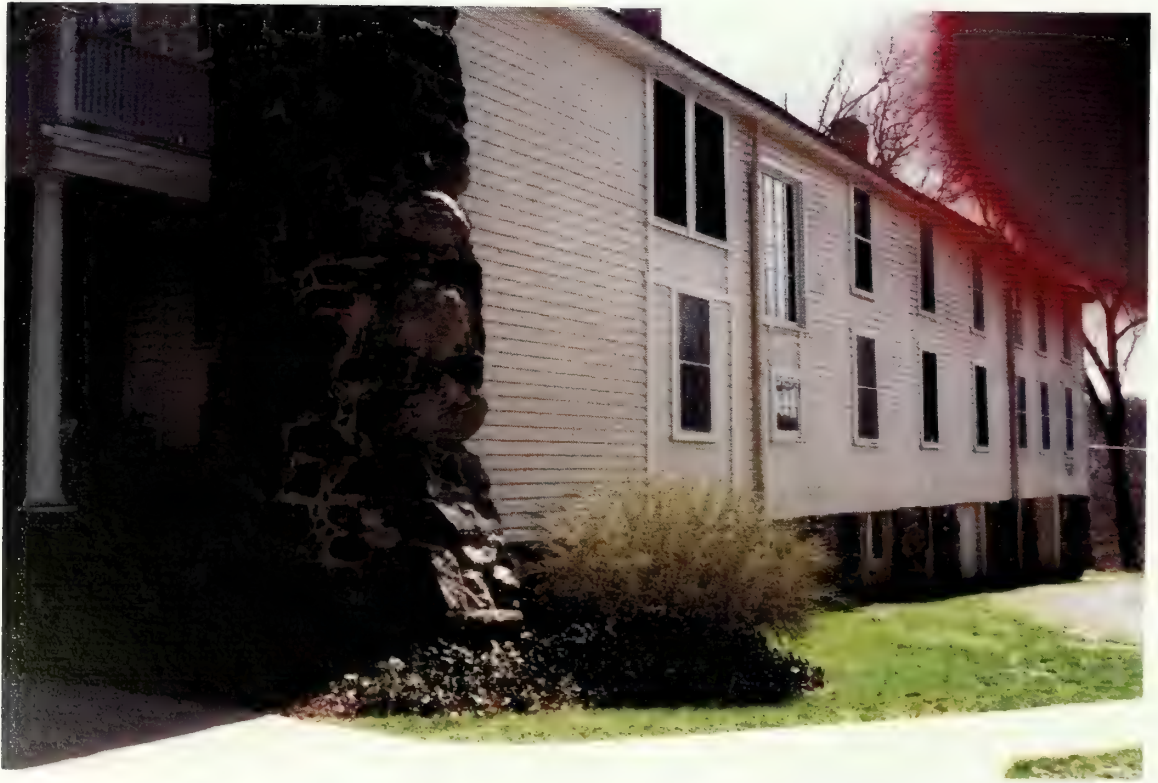
Figure 90: View of northwest elevation of the Clara Barton House showing some of the different types of German siding used on the house. Typically, the vertical trim board separate section of different siding. Also note the large 24 light window installed in the main stair well, the small six light sash installed below it, and the six-over-six windows that run along the side and rear elevations of the house.

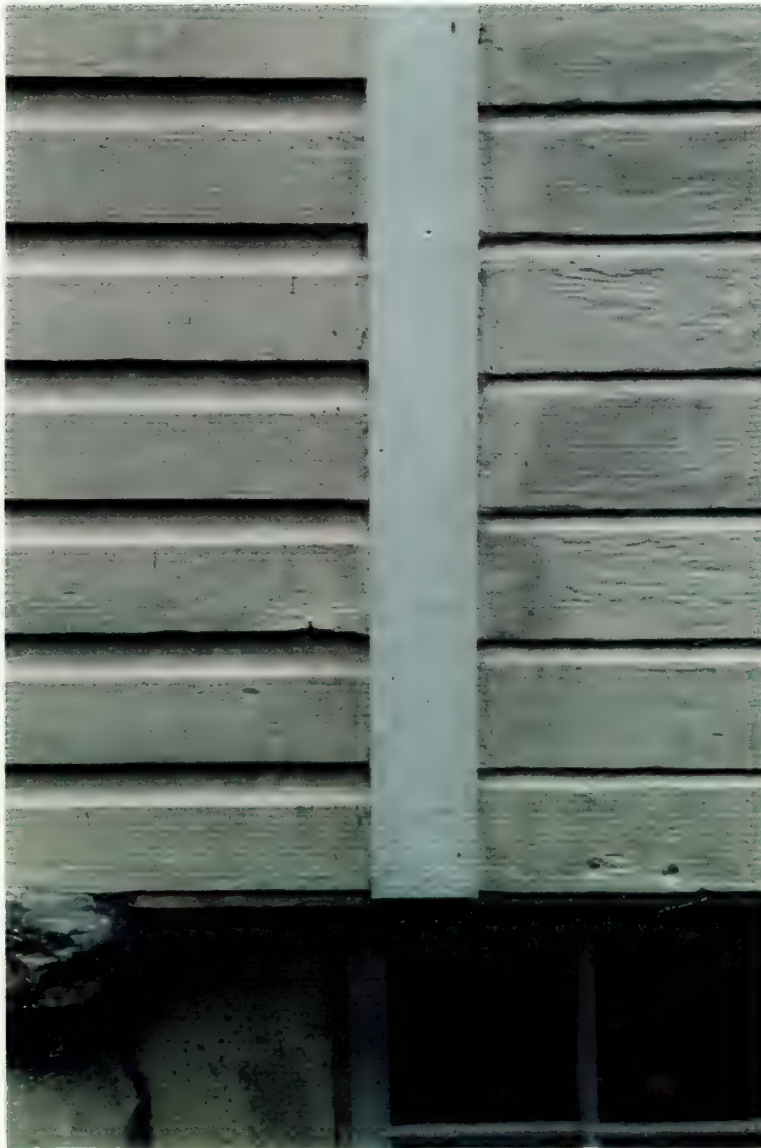
Figure 91: Close-up view of two types of German siding on the northwest elevation. The siding on the left covers the brick wall of the safe.

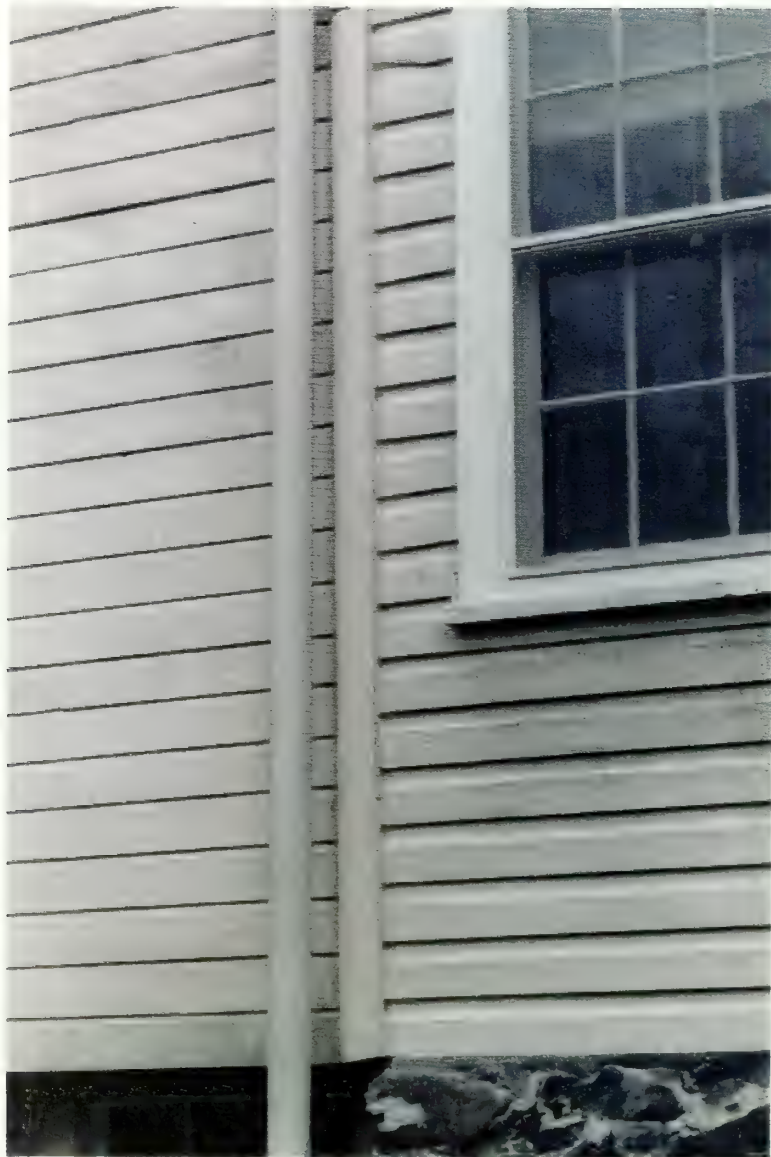
Figure 92: Close-up view of two types of German siding on the northwest elevation. The siding on the left is the replacement siding installed by the NPS after the side entrance and stair were removed..

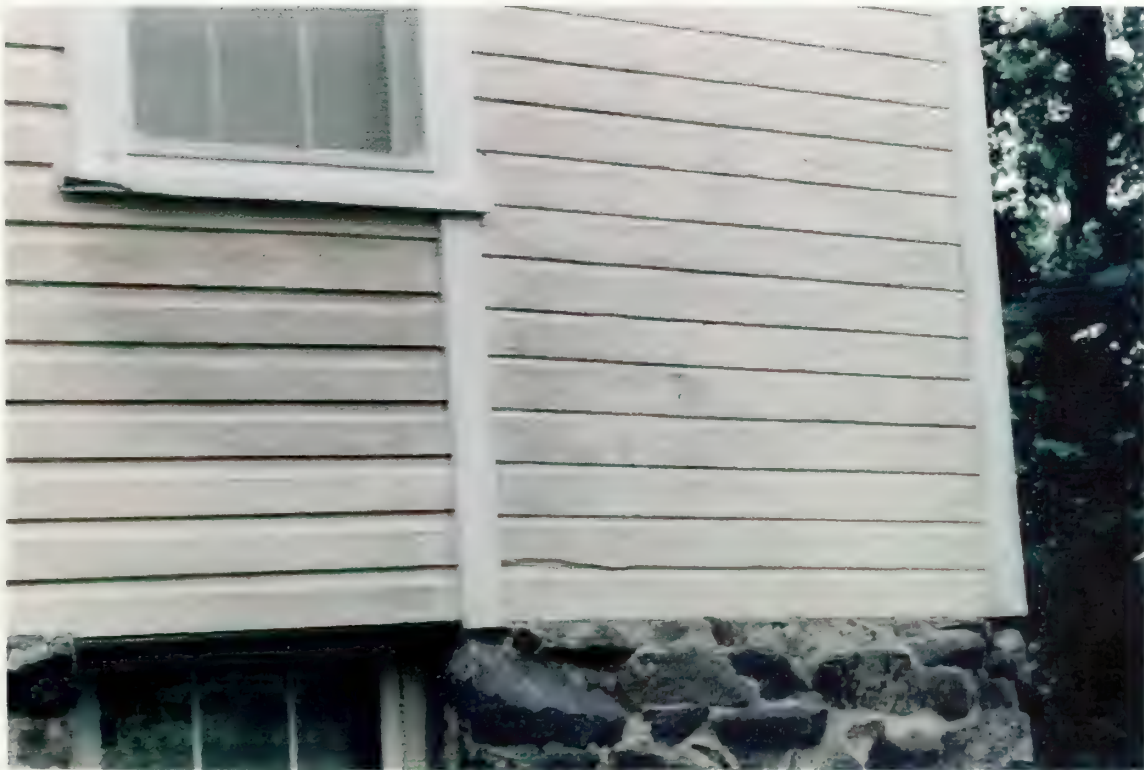
Figure 93: Close-up view of two types of German siding on the west corner of the northwest elevation.
